The track obstruction by a road vehicle and subsequent train collisions at Great Heck 28 February 2001

A report of the Health and Safety Executive investigation

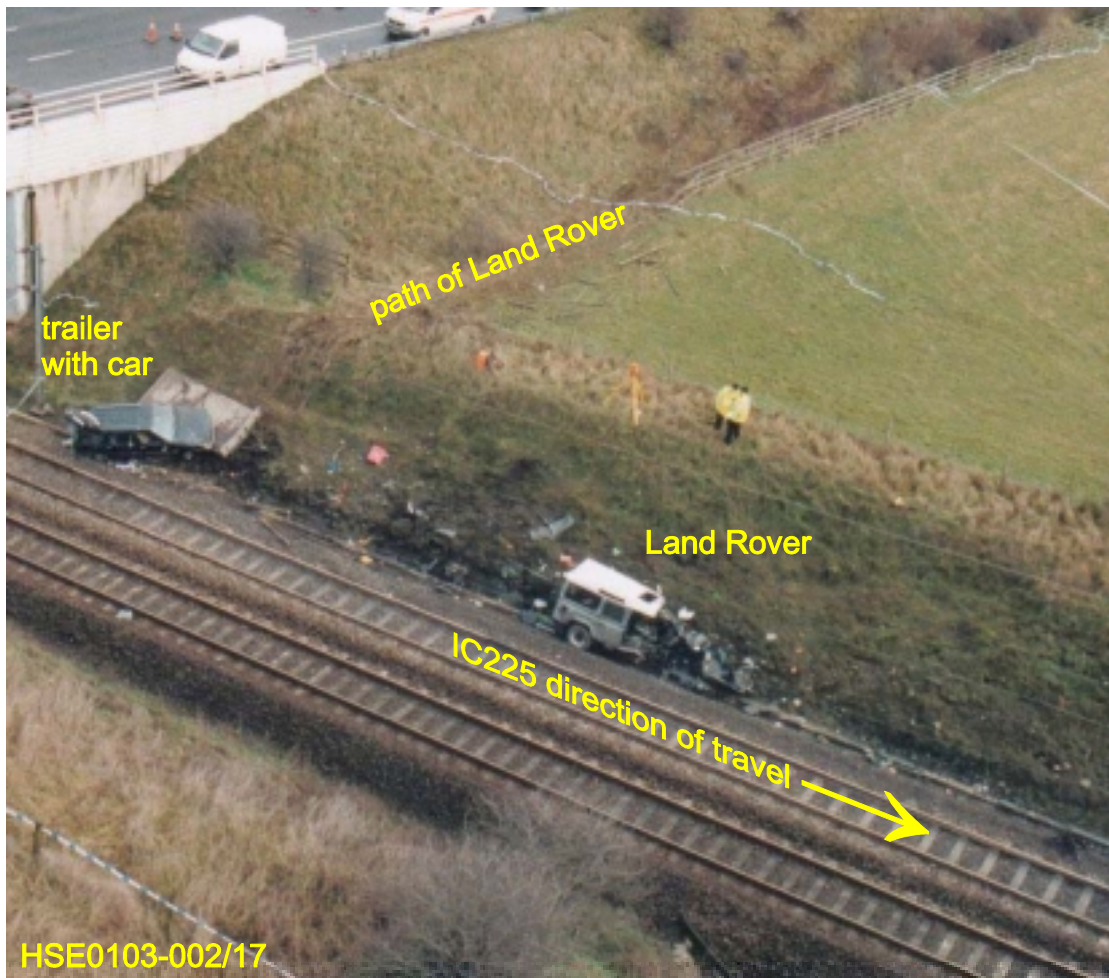
Figure 5: **Photograph of the M62 road bridge incident site showing the remains of the Land Rover next to the Up line**

3.6 The Land Rover was about 11 metres south of the M62 bridge. At impact the IC225 is considered to have been travelling at between 120 and 125 mph. The impact caused the leading bogie on the DVT to derail at a distance of 48 metres beyond the impact point. The remains of the Land Rover following the impact, and the adjacent motorway embankment down which it travelled are shown in the photograph in **Figure 5**.

north, towards the IC225. The front wheel was 11.5 metres from the south face of the M62 bridge. The nearside Land Rover tyre was deflated, the consequence of tyre penetration by a broken wooden fence post.

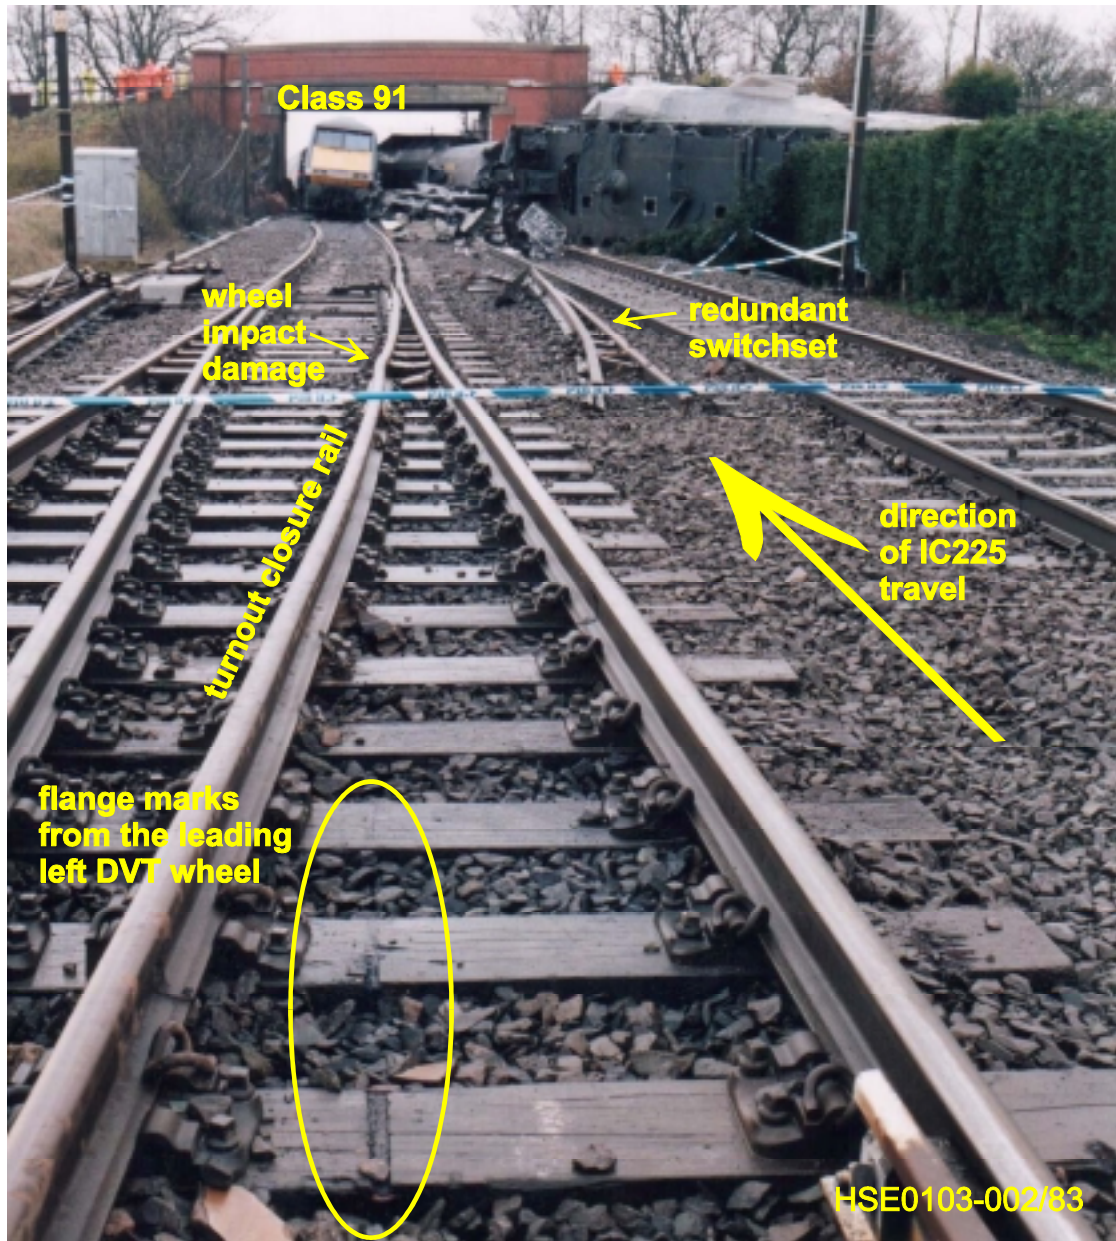
Figure 6:

5.10 After hitting the Plasmor Sidings closure rail the leading end of the DVT was redirected towards the Down line. As noted earlier (in 3.10), a redundant switchset was lying out of use in the six-foot south of the Plasmor Sidings turnout. The underside of the obstacle deflector in front of the leading DVT bogie and the right-hand leading wheel made contact with these. There was no evidence that they influenced the movement of the IC225 train and its subsequent collision with the freight train.

6.2 The trailing turnout to Plasmor Sidings consists of a CV 9¼ turnout. Both left and right-hand switchsets had been renewed in October 2000 as a result of defects associated with gauge corner cracking.

6.4 Inspection for rail cracks, carried out every six months, had shown a problem with the turnout to Plasmor Sidings on 2 August 2000. As a result the turnout switchsets were replaced on 1 November 2000. The scrap switchsets were left on the formation, one in the cess and the other in the six-foot between the tracks, awaiting programmed removal on 10 March 2001.

Photograph of the Plasmor Sidings turnout looking south towards the Pollington Lane bridge

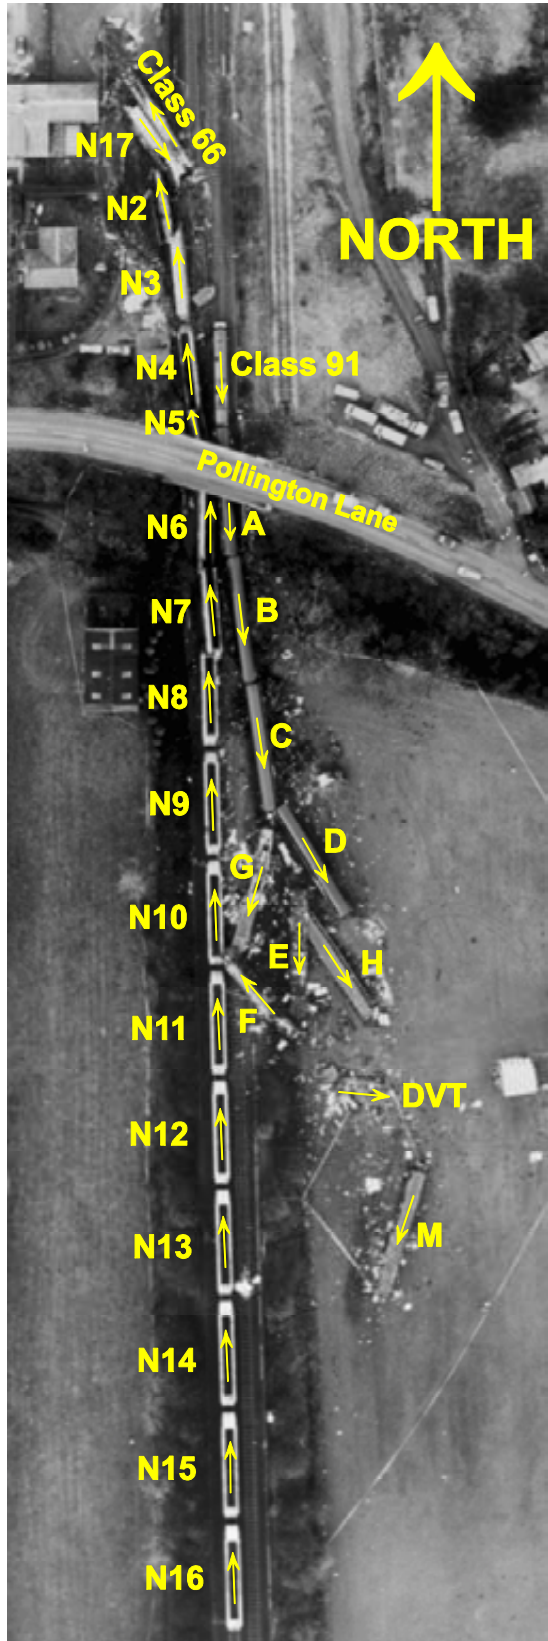
Figure 7:

Aerial photograph of the collision site between the IC225 and the freight train

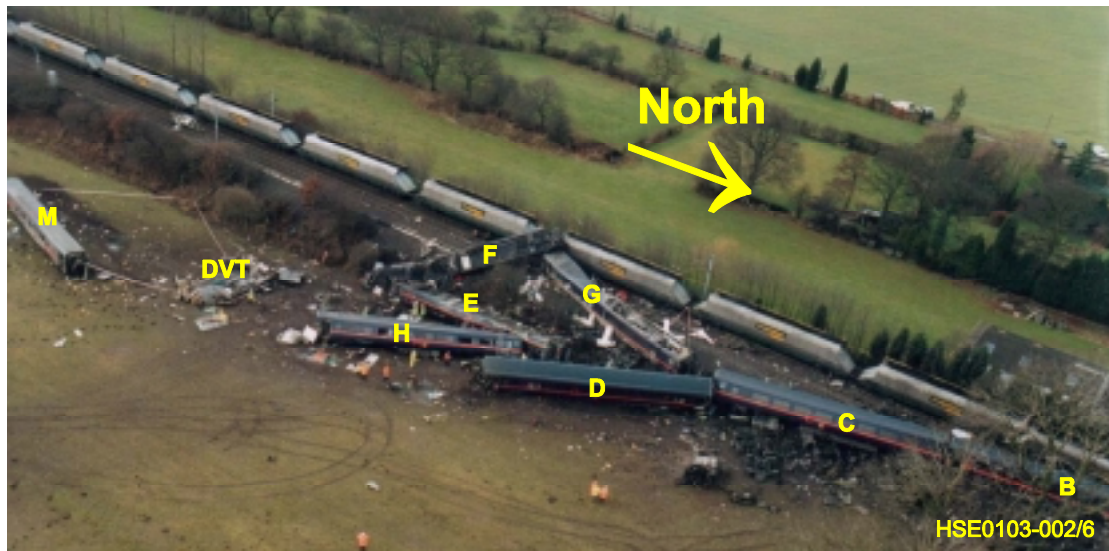
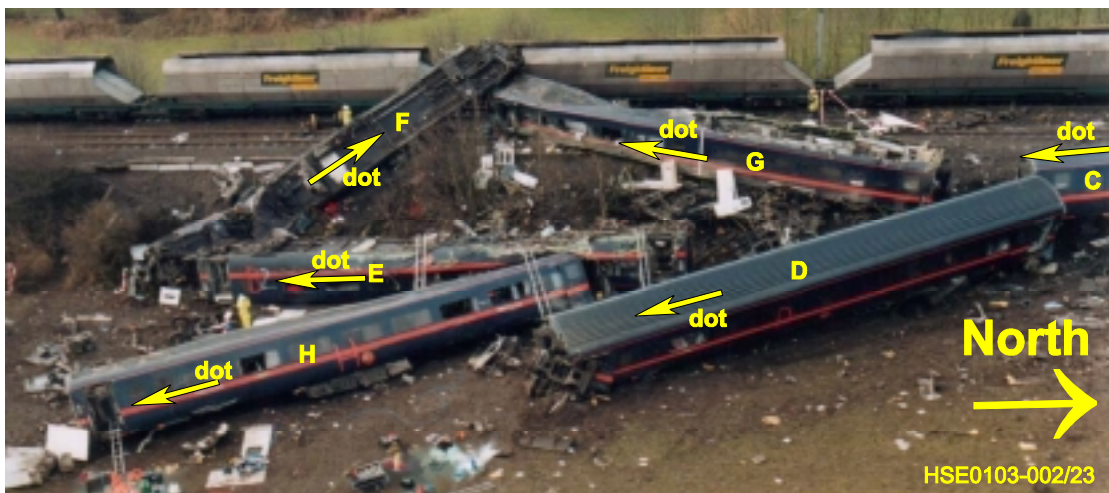
Figure 8: Aerial photographs of the collision site showing the coaches of the passenger train

7.17 Coach F, a seventy-two seat vehicle, came to rest on its left side on the face of the embankment, as seen in **Figure 8**, with the leading end supported by Coach G and a freight wagon. At the leading end about 2 metres of the right side were missing. There was very significant damage to the floor about the sixth window position from the leading end, as shown in **Figure 12**, such that the floor met the folded roof, which eliminated survival space associated with twelve seats. Many seats on the right side had come loose, or had been removed by the emergency services. Due to significant distortion of the right side relative to the floor, survival space associated with the window seats down that side was reduced. Some of the ceiling panels and luggage racks had become detached. Survival spaces in the leading vestibule and toilet were also totally compromised. All windows were broken, and all four external doors missing. The underfloor equipment and bogies were missing.

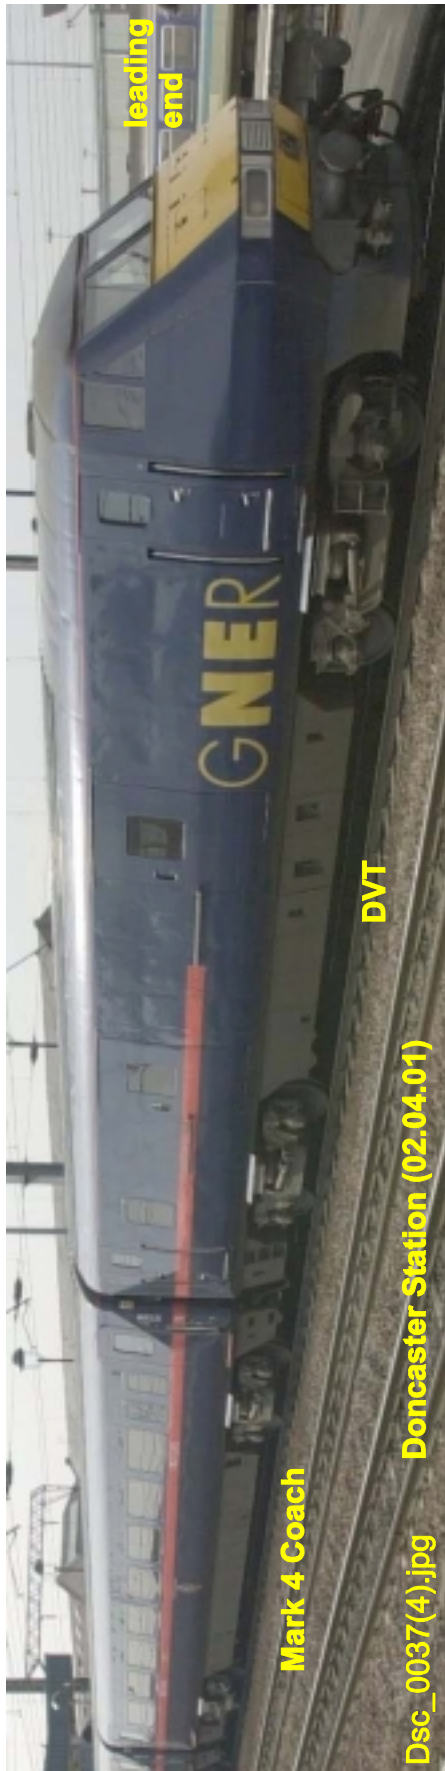
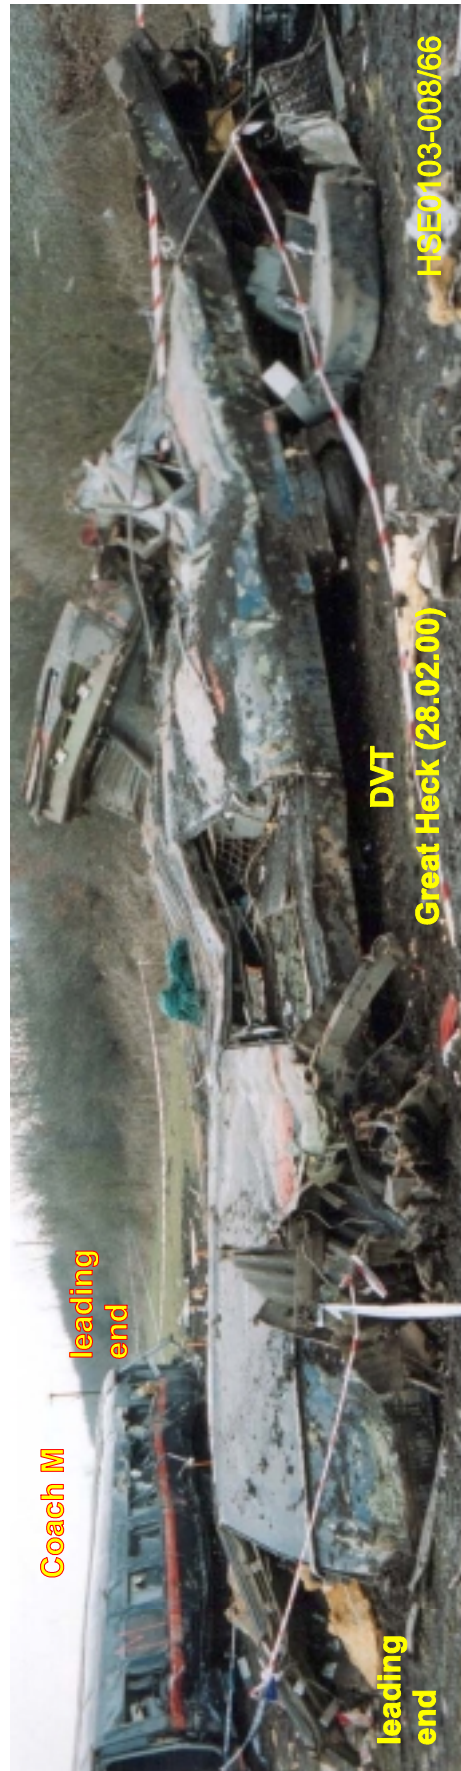
Figure 9: The driving van trailer

5.19 Meanwhile, the heavily damaged DVT came to rest, facing away from the embankment, some 105 metres from the bridge, as shown in **Figure 9**. Coach M, on its left side, bounced onto and over the DVT and rotated further,

7.10 As the DVT was the first vehicle to collide with the Class 66 locomotive it suffered massive structural damage, resulting in large sections of the vehicle becoming detached and dispersed over the crash site. The leading end cab structure was sheared off, and a 3 metre length of body section following this totally destroyed. The floor structure beneath the cab also became separated,

7.12 The IC225 DVT suffered massive global impact damage during the collision with the freight train, as shown in **Figure 9**. This was a consequence of the relatively lightweight nature of the DVT (45 tonnes) in comparison to the freight locomotive (127 tonne), and also the lower ride height that was further reduced by the DVT being derailed prior to impact with the Class 66. The driver's cab was demolished and separated completely from the underframe. Any crashworthiness features of the DVT were totally compromised by the masses and speeds of the vehicles involved in the collision.

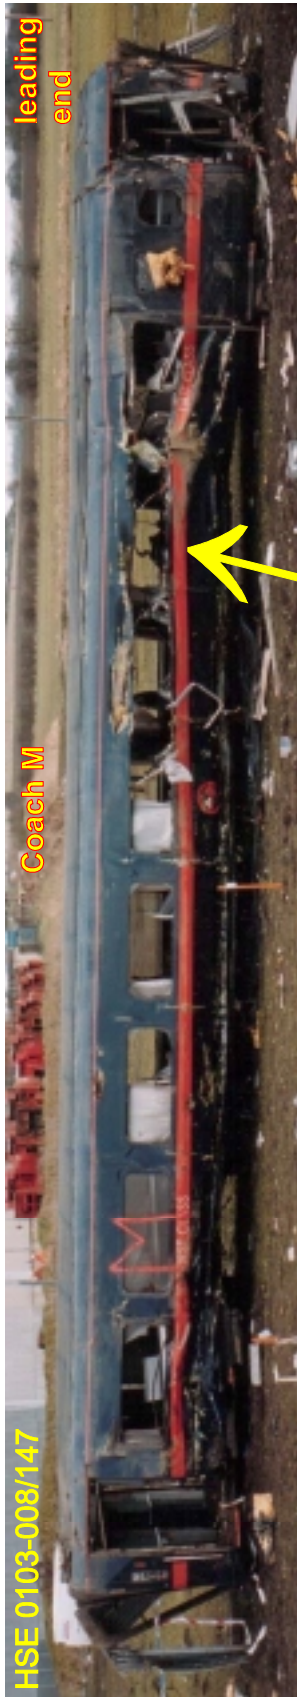
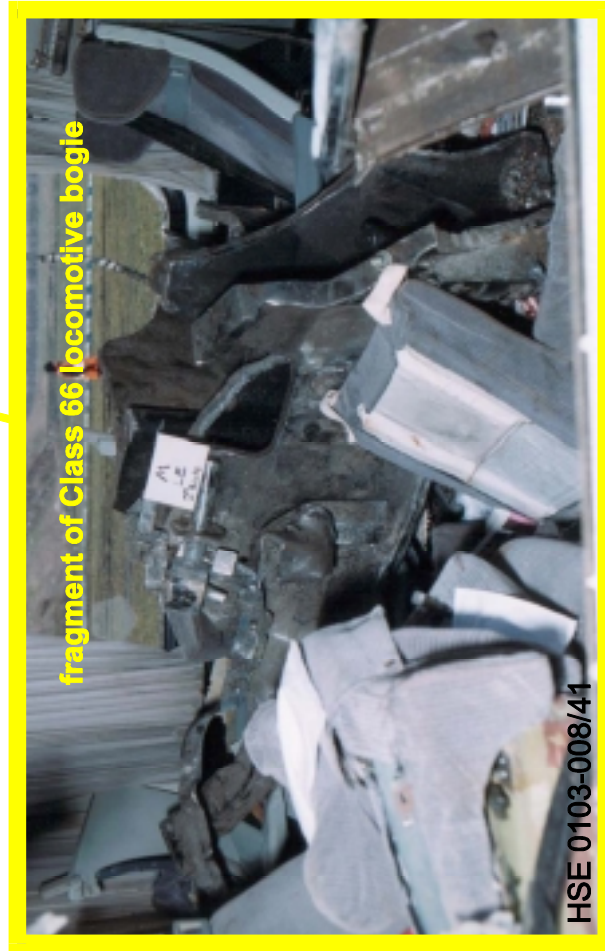
Figure 10: Coach M

7.14 Coach M came to rest in an upright position on level ground, as shown in **Figure 10**. This coach had forty-six seats. The leading end contained a large piece of the leading Class 66 bogie that had broken away and entered on the right side, cutting through the body side and removing the leading four windows. This completely compromised survival space at up to six seat locations. Above this the central ceiling panel had fallen away. Four windows on the left side were missing. The headroom was reduced over the trailing half of the coach due to the floor structure being significantly buckled. Many of the seats were detached from the floor. Both bogies and most of the under-floor equipment were missing, as were all but one of the four exterior doors.

7.29 Many of the First class seat structures buckled, resulting in loss of space under the seat. In Coach M most of the seats became detached from the floor through failure of the holding down bolts, unlike those in Coach H. Many of the chromed arm rests also detached, and when completely free became potential missiles. The majority of padded headrests also became detached, which increases the risk of head injuries, and also results in further missiles.

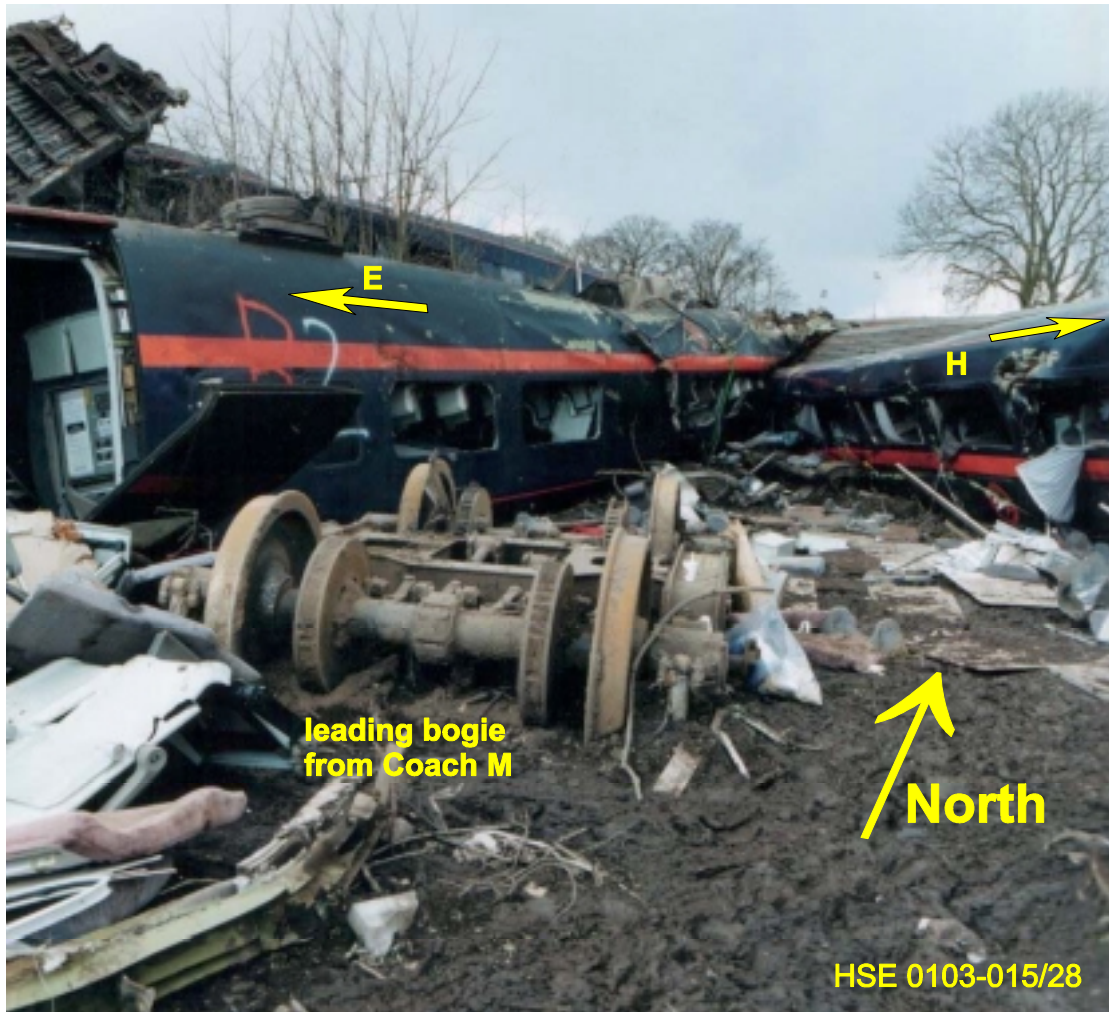
Figure 11: **Coaches H and E**

7.18 Coach E, a seventy-two seat vehicle, came to rest upside down on level ground, with its right side punctured by Coach H towards the trailing end, as can be seen in **Figure 11**. This caused a total loss of survival space associated with eight seat locations. All but three of the windows were broken, and the external doors at the trailing end were missing. A part of the roof had been torn off over a length of about 4 metres towards the trailing end. Much of the under-floor equipment had been lost, as had the bogies.

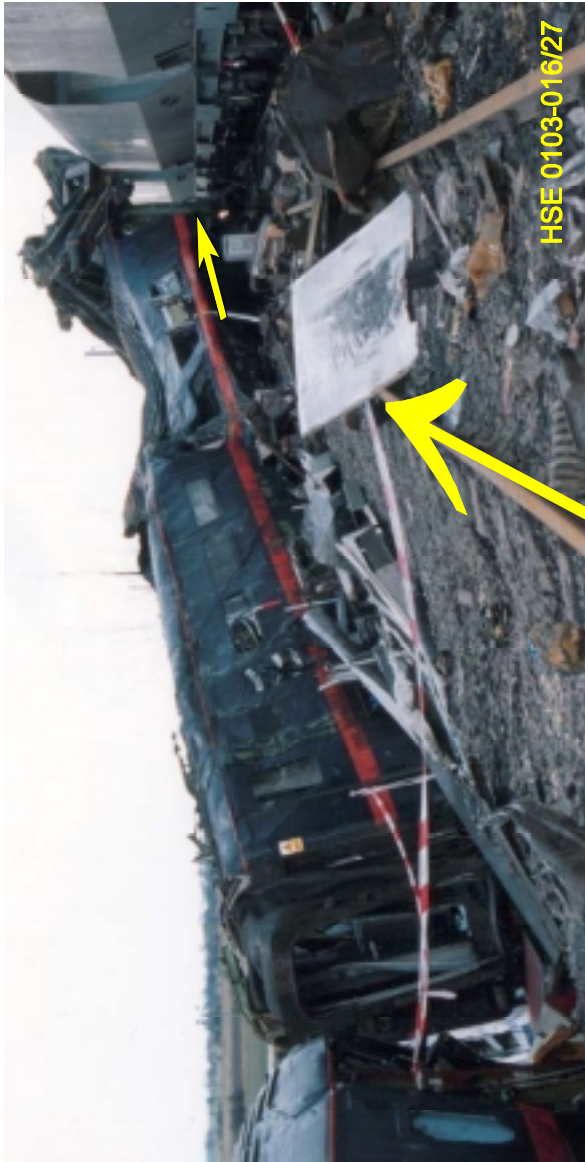
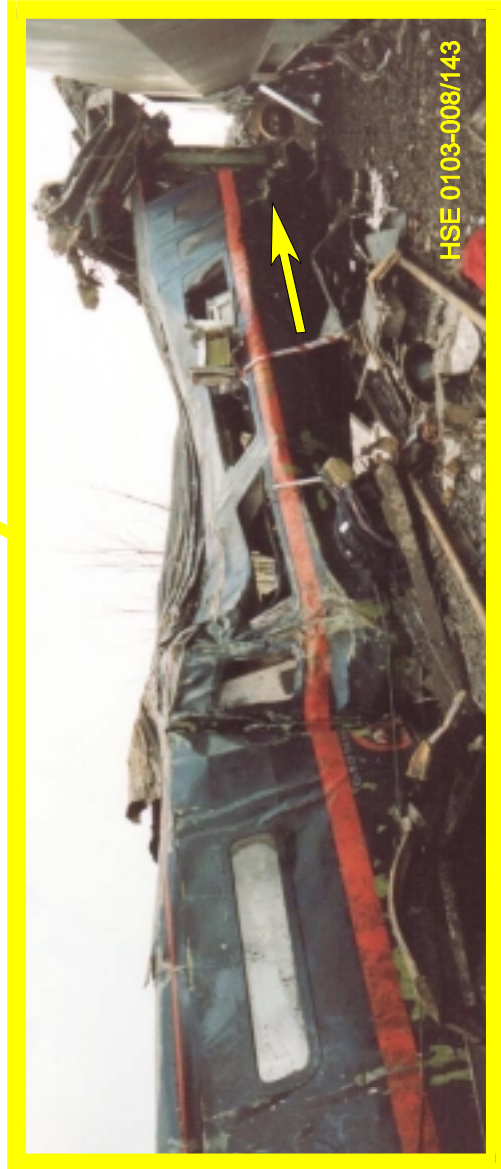
Figure 13: **Coach G**

7.16 Coach G came to rest in an upright position on the face of the embankment, as seen in **Figure 13**. This vehicle had twenty seats in the leading half, and a kitchen and buffet. The leading end had been heavily damaged. The roof over the seated portion had been flattened, while that over the kitchen and buffet had been torn away. The body shell was bent about a deep vertical crease at the mid-point of the right side. All but one of the windows in the seated area was broken. Both bogies and the under floor equipment had become detached. Internally survival space was completely compromised in the staff toilet and rest area, and at four seat locations. Buckling of the roof in the seated area had brought down ceiling panels and electrical equipment, which together with the buckled floor seriously reduced headroom. Large amounts of debris filled the kitchen and buffet area.

7.31 In the kitchen area of Coach G, there were a large number of unsecured items with the potential for becoming missiles. Though the large items of equipment were adequately secured in this area, many had sharp edges with the potential for serious injury, as had the counters. The equipment used for at-seat catering, including cutlery and crockery, was found scattered throughout Coaches M, H and G.

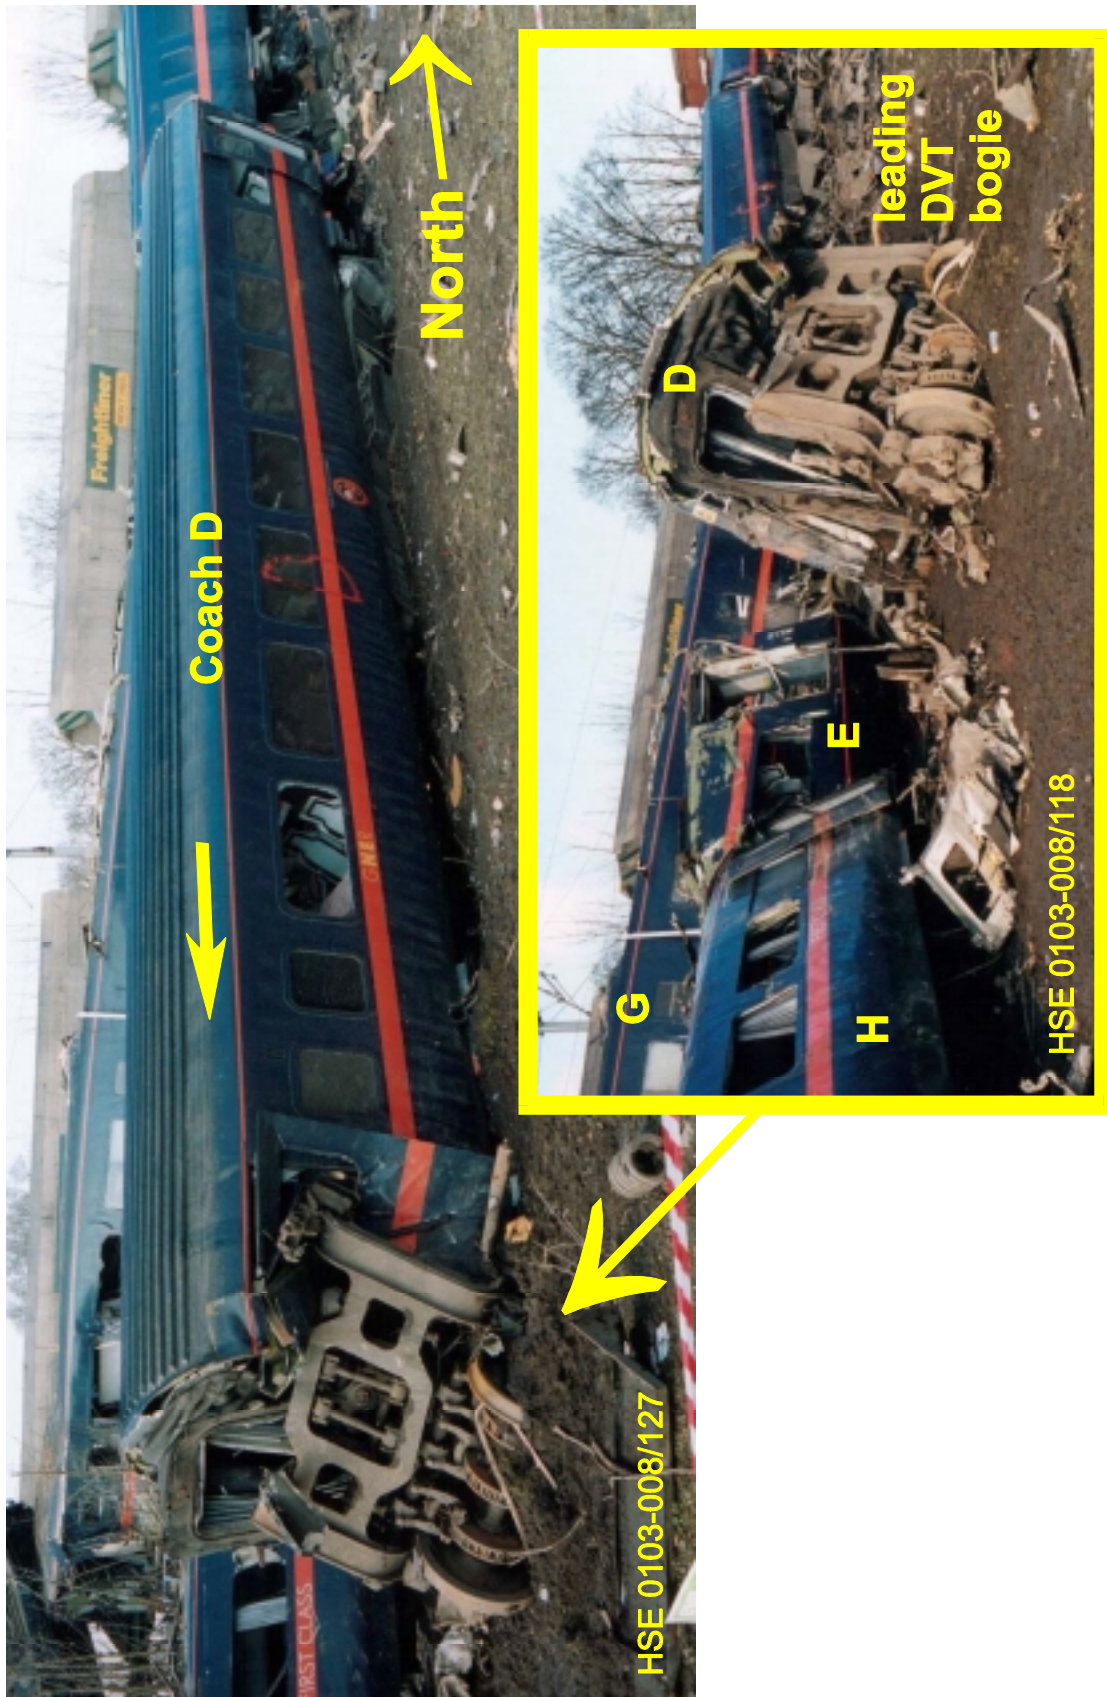
Figure 14: **Coach D**

5.21 Coach D traversed the embankment and stopped 60 metres south of the bridge with a detached bogie, shown in **Figure 14**, embedded in its leading end. This bogie was probably that which caused the floor penetration of Coach F. Coaches C and B were dragged down the face of the embankment and stopped 40 metres and 15 metres south of the bridge. Coach A came to a standstill beneath the Pollington Lane road bridge on the line of the track with the Class 91 locomotive behind just to the north of the bridge, also correctly aligned on the track-bed.

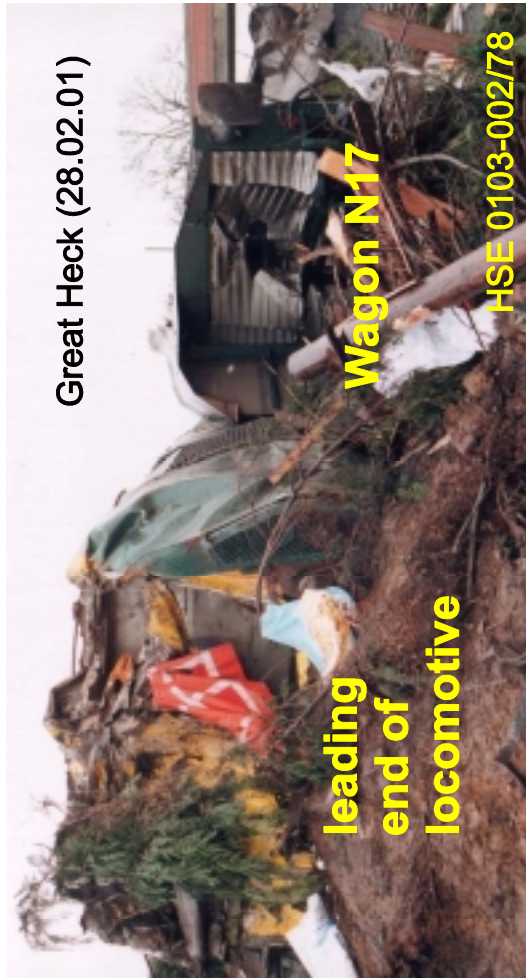
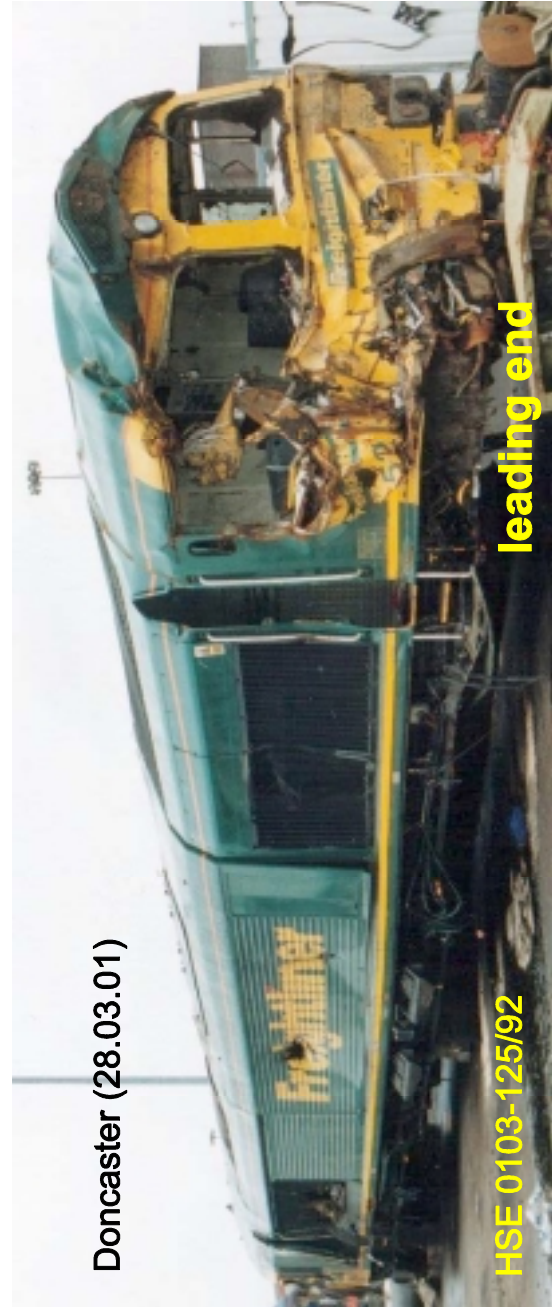
Figure 15:

7.42 Following collision with the IC225 DVT the locomotive came to rest on its left side on level ground, as shown in **Figure 15**. It was heavily damaged on the front and right side, and below the cab in the vicinity of the missing right buffer, with part of the DVT embedded below the right front window. The interior of the leading cab was mainly intact, but all the windows were broken. The two drivers seats were undamaged and fixed to the floor. The survival space about the right-hand seat had been reduced below waist level. The trailing cab had also sustained impact damage, but the interior survival space had not been affected. Both the end windows were broken. All underframe equipment, fuel tank, and bogies had been stripped from beneath the locomotive during the course of the collision. The fuel tank was ruptured during the collision and released its contents, though none ignited. However, an oil film was found on many of the coaches and wagons.

7.43 The leading bogie of the locomotive sustained significant impact damage to its front and right side. A large portion of the leading end detached, and this came to rest in the leading end of Coach M. The bogie unit was deformed, and all the wheelsets and traction motor components had detached. The trailing bogie had also sustained heavy impact damage, to both the leading and trailing ends, on the right side. All the wheelsets and traction motor components were also missing from this bogie.

7.45 As noted above, the fuel tank, made from steel plate, had detached from the locomotive and been ruptured and all of the fuel lost. The tank had no design features that could prevent the potential total loss of contents upon rupture.
