The track obstruction by a road vehicle and subsequent train collisions at Great Heck 28 February 2001

A report of the Health and Safety Executive investigation

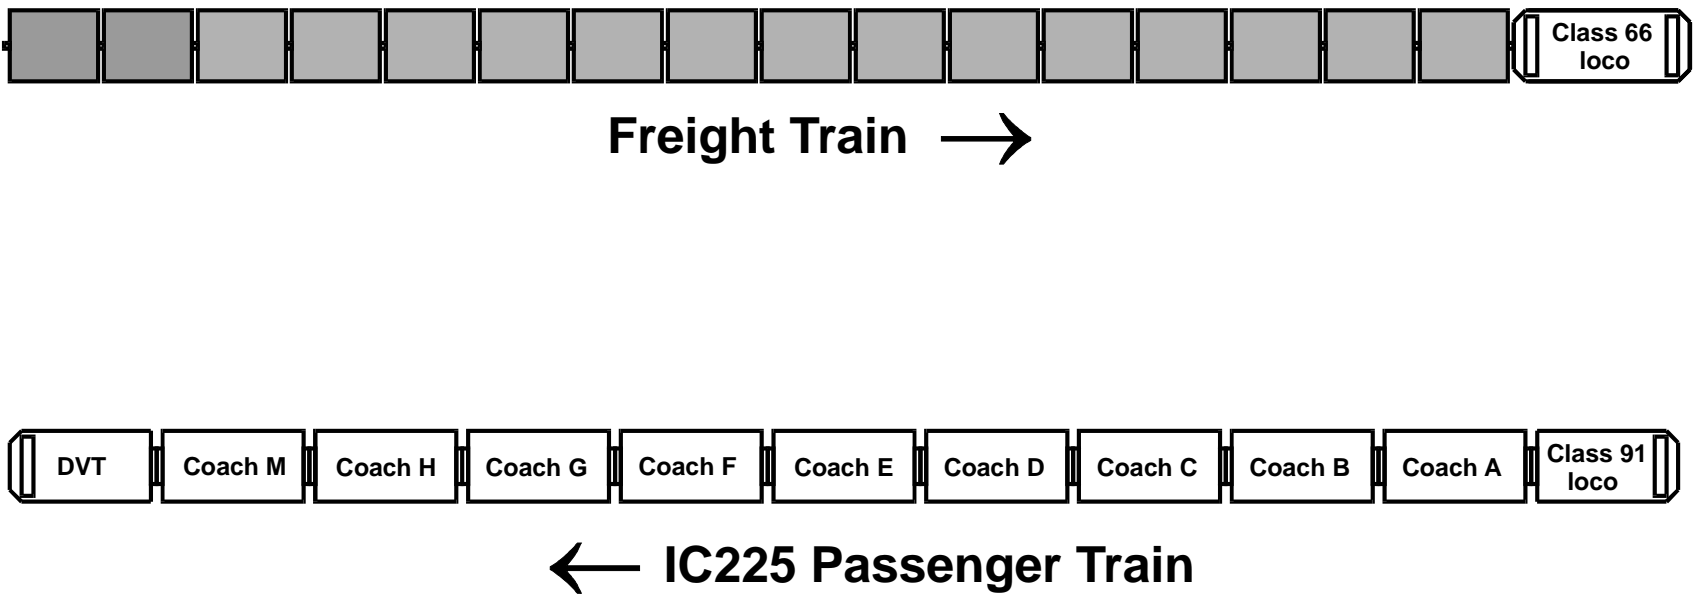
Figure 4:

3.3 The make up of both trains is shown diagrammatically in **Figure 4** and described in detail in section 7.

Diagrams showing the make up of the trains as running prior to the collision
